DOLE RESERVOIR DAM & DIKE

NH 00143 & NH 00483

PHASE I INSPECTION REPORT NATIONAL DAM INSPECTION PROGRAM

MARCH 1980

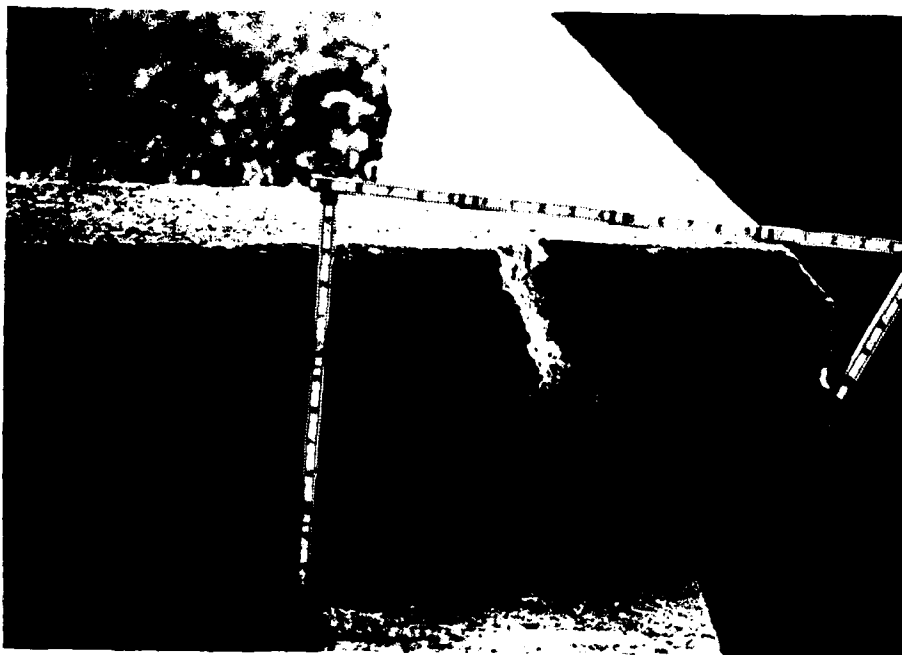
The left end of the embankment is retained by a concrete wall, 15 inches wide and about 7 feet high, which also acts as a training wall along the right side of the spillway discharge channel (see Plans and Details in Appendix B). This wall is partially undermined by erosion at its downstream end and is also about 4.5 inches out-of-plumb because it is tilted toward the west (see Photo No. 15). The embankment immediately adjacent to the wall appears to have subsided about 6-8 inches relative to the top of the wall. There is a 1/4-inch wide crack in the concrete and spalling at the corner where the training wall meets the embankment wall, due to this tilting (see Photo No. 17).

- (5) The poor condition of the concrete wall which retains the left end of the dike embankment and also acts as a training wall on the right side of the spillway discharge channel indicates the possibility that the wall may topple over and lead to breaching of the dike.

Photo No. 17 - Crack and spalling of upstream end of right training wall of spillway discharge channel.
